Background

As part of its preparedness activities, the Logistics Cluster has been working on emergency preparedness for a potential Mosul Dam incident since May 2016. A previous mission was conducted on 17 August 2016 to enquire about the key indicators at the Dam. Following the continued preparedness planning activities of the Logistics Cluster, a subsequent mission was planned with the added participation of the World Food Programme (WFP) emergency preparedness function. The joint mission of Logistics Cluster and WFP took place on 30 March 2017.

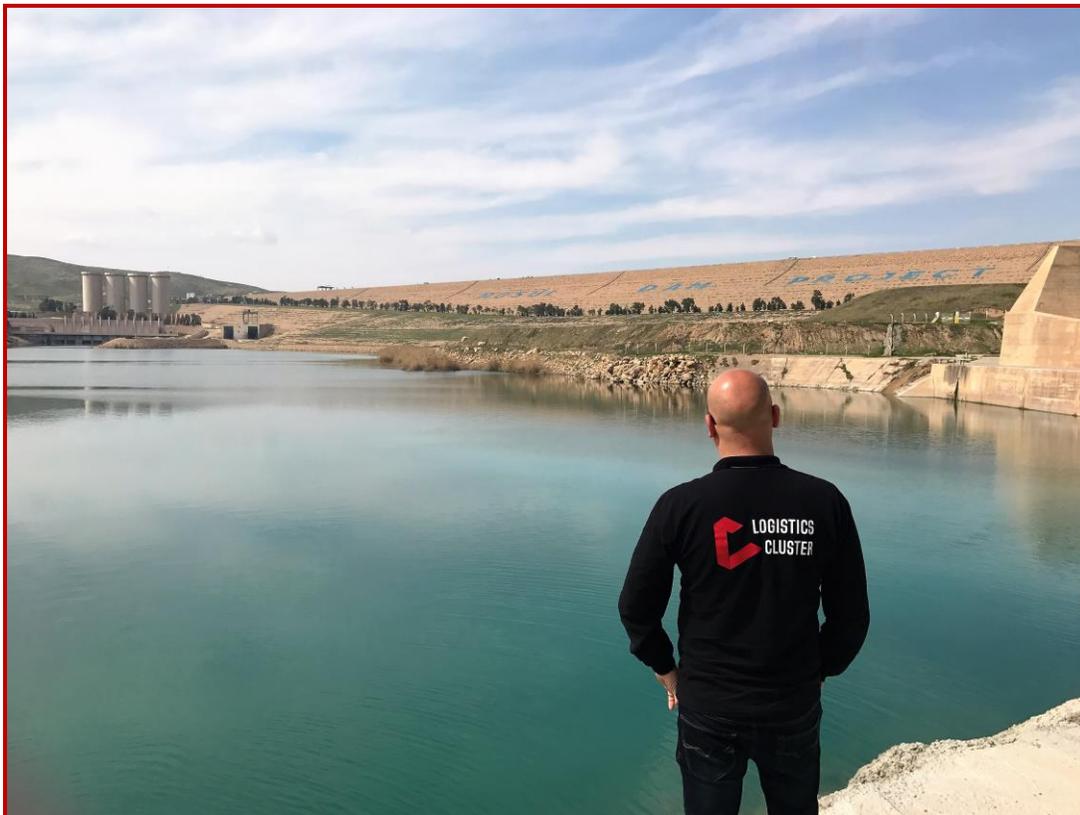
Figure 1: The bottom end of the spillway, showing the power generation water storage and the bottom outlets.

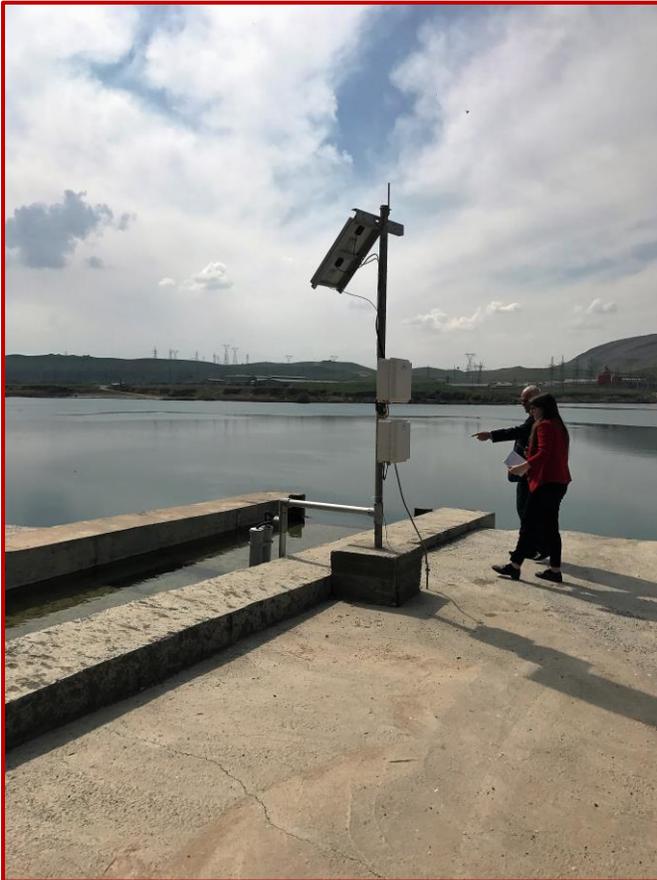
Previous reports (Schnabel) confirmed seepage indicating leakages through the ground. New instruments have been placed along the seepage channels and monitoring is being done continuously with the instruments reporting data every ten minutes. According to Dam officials, no alarming data has been transmitted about the seepage outflow (the flow is within expected parameters).

Figure 3: Seepage measuring instruments (real time feedback).

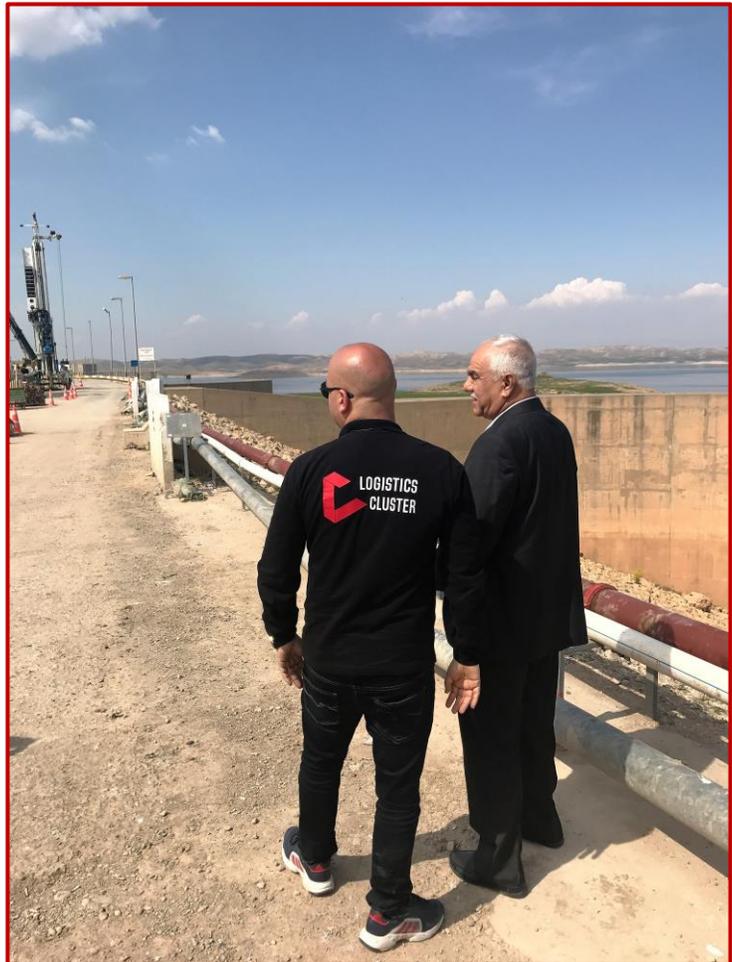
Trevi has started full operations on the Dam. They have eight grouting rigs in the gallery and three more grouting stations in the embankment, as shown in Figure 4. According to the Dam manager, Trevi has introduced valuable technology and software services that will make the Dam maintenance operations more effective and efficient. A new specifically-designed software has been introduced by Trevi to allow for better monitoring and management of the water flow and pressure of the grouting operations. In addition, Trevi has introduced instruments into the grouting machines that allow a camera to be inserted into the grouting hole to determine the effectiveness of the grouting operation without the need for the expensive and cumbersome sample extraction method used earlier. Trevi is also training the Iraqi engineers and staff to maintain the Dam without their support and have introduced small changes to the grouting mix. The current contract for Trevi expires on 27 November 2017 and it is expected that the equipment left behind will be operated by the Iraqi maintenance crew who are currently working side by side with Trevi.

Figure 4: Trevi grouting on left side of embankment.

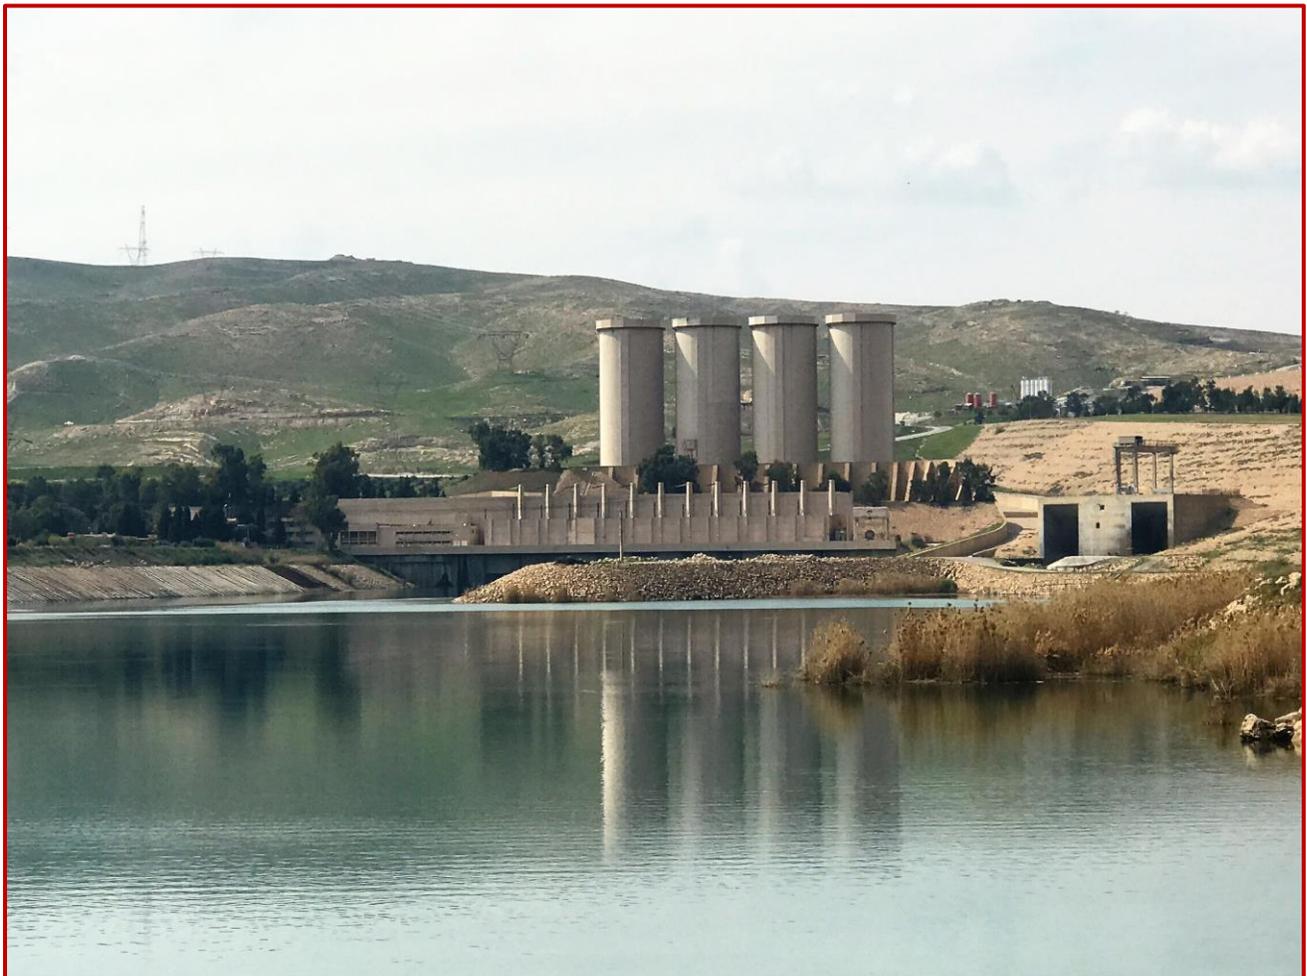
Figure 5: The power station and bottom outlets.
